## Eddy Current Array inspection Johannesburg 2018

**PATRICK CABANIS**  
Senior Product & Application Specialist  
NDT Level 3.

**OLYMPUS EUROPA SE & CO.KG**

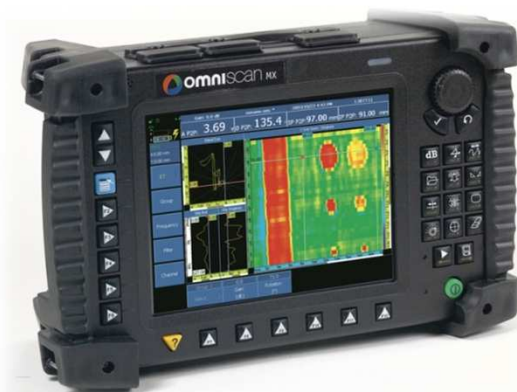
## OMNI-P-ECA4-32

- Conventional and Array ECT
- 4 input channel
- 32 channels
- 64 channels with external multiplexer
- 1-Analog output
- Frequency range from 20Hz to 6MHz
- Dual Frequency operation ECA
- 8 Frequency operation EC
- 2-Encoder input
- 3-Alarms output

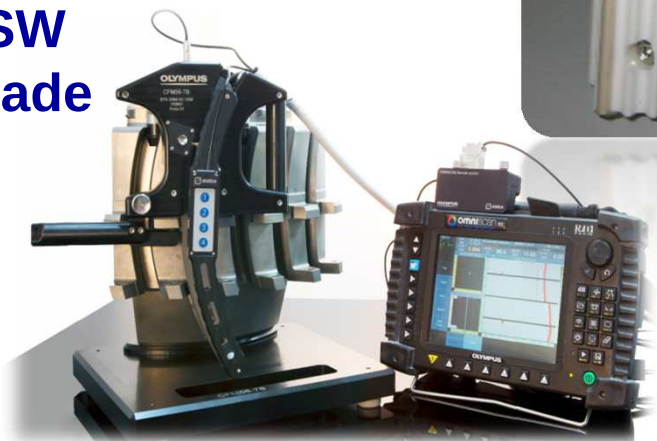
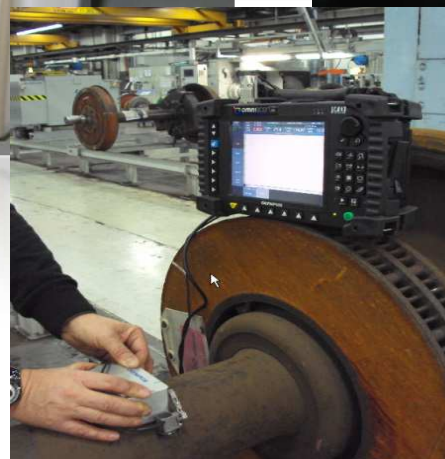
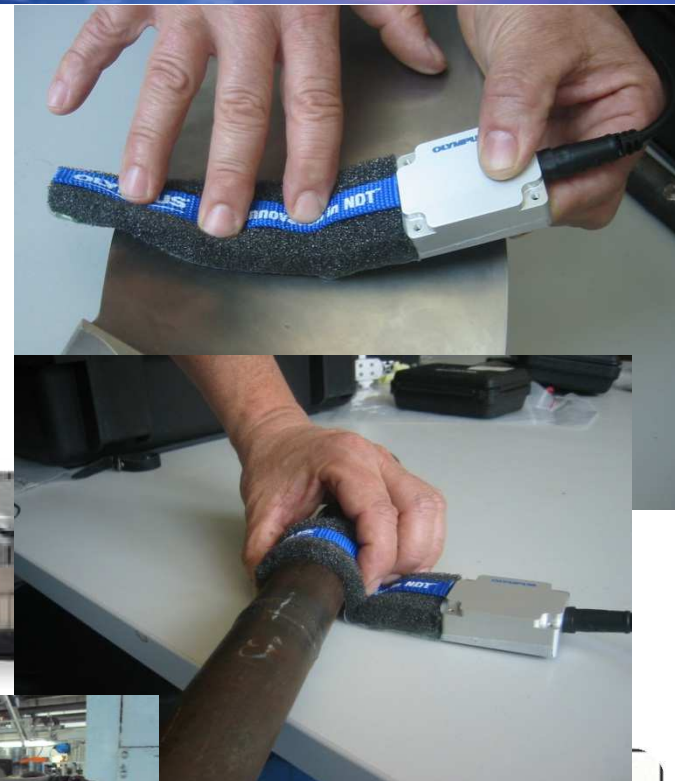
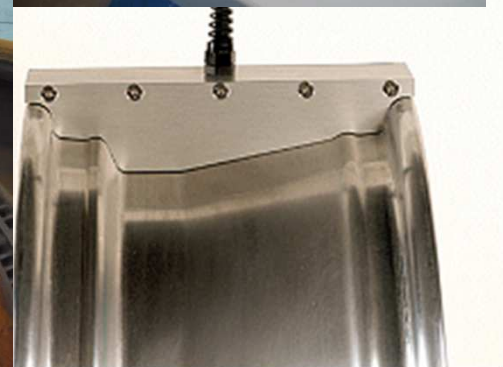
## ECA probes application

- Aircraft Corrosion
- Tubes inspection
- Gaz Turbine
- Pipe
- Rails
- Dovetail
- Train axis
- Doubler edge
- Weld
- FSW
- Blade

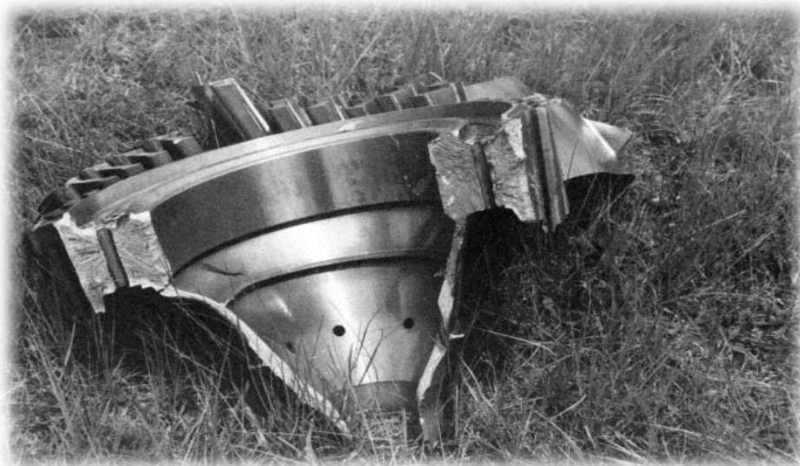
### Historic : accident, pensacola, florida

- Engine failure on take-off roll
- Pilot aborted take-off
- Stage 1 Fan Disk separated; impacted cabin
- Life Limit: 20,000 cycles. Failure: 13,835 cycles.

⇒ Represented second major premature failure of a engine disk in service due to unanticipated and undetected damage

**Eddy current inspection  
on disk**

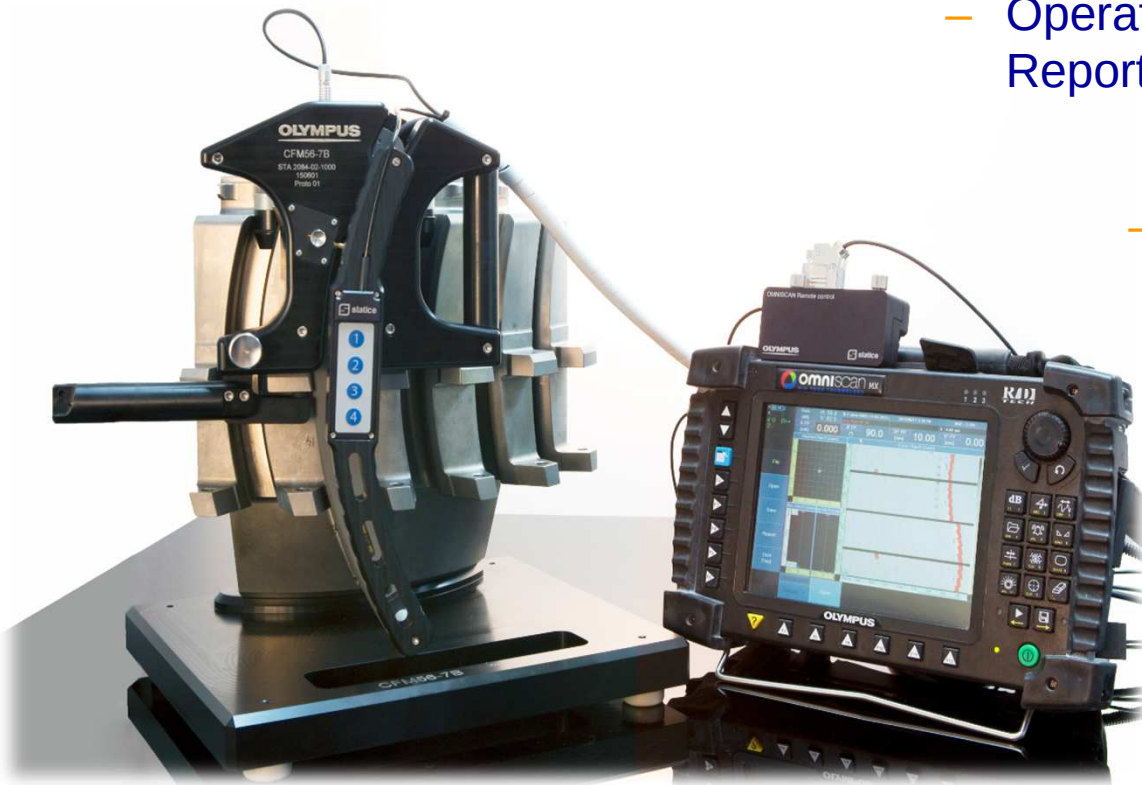
- Encoded Acquisition
- Guided Scanner

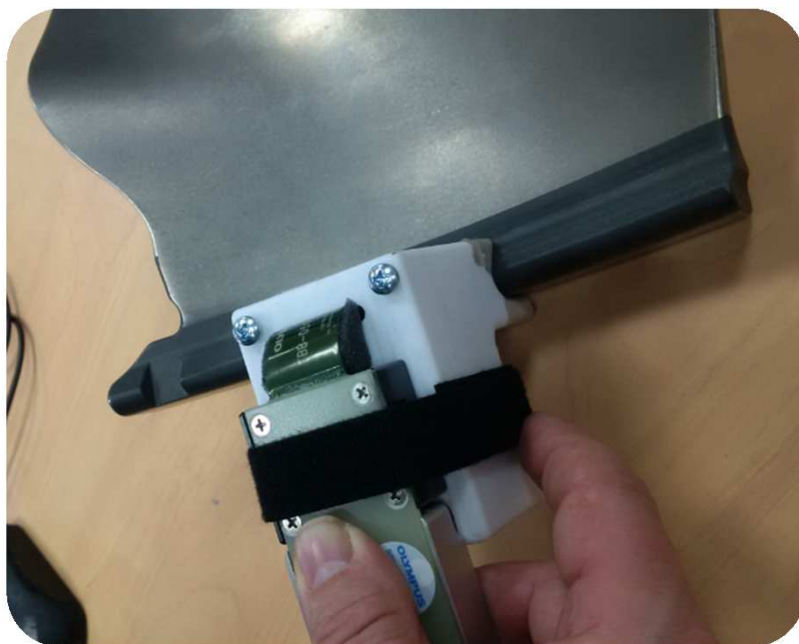
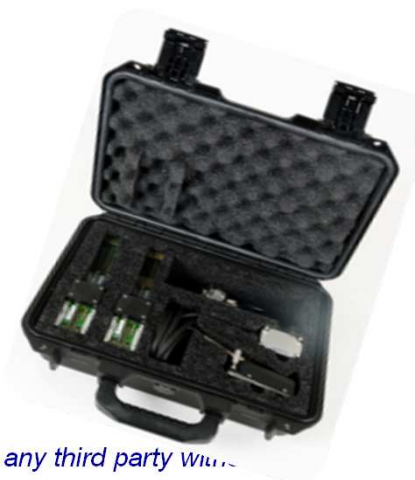
## First Step

Given the severity of the problem, the first step was the development of a very simple ECA inspection means but quickly available...

Omniscan ECA + ECA flexible probe + 3D printer probe holder

- 6 omniscan ECA
- 24 ECA flex probe
- 12 ECA cable

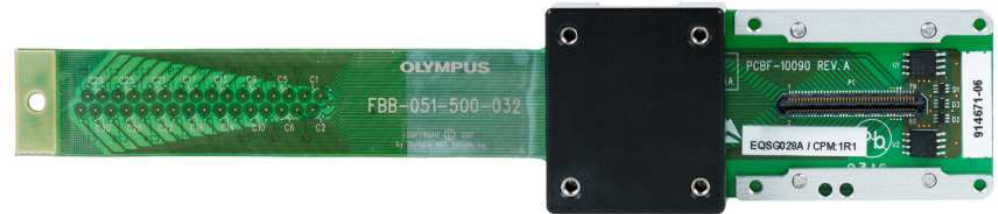
## ECA - Flexible Probe

➤ **Two mode**

**Absolut**  
**Need a encoder**

**Reflection**

**More sensitive to small defects**

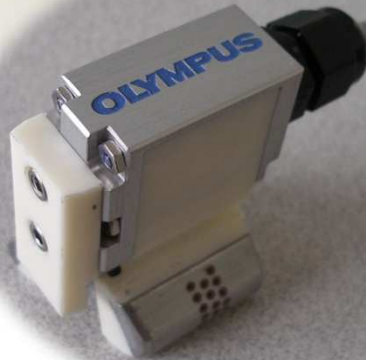
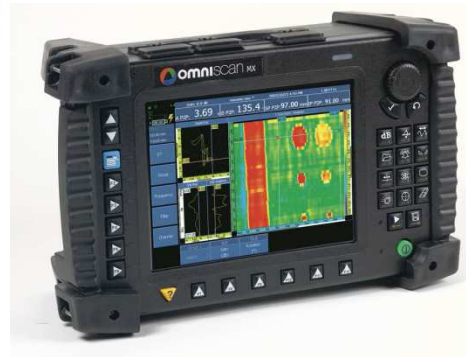
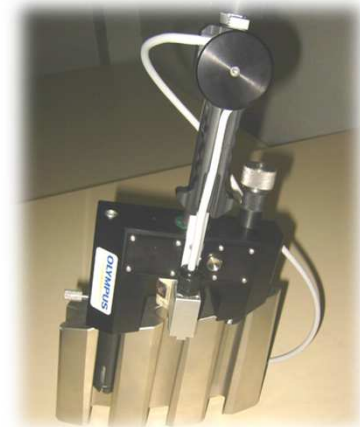
# Engine disk dovetail slot Inspection

- **ECA probe**
- **32 elements**

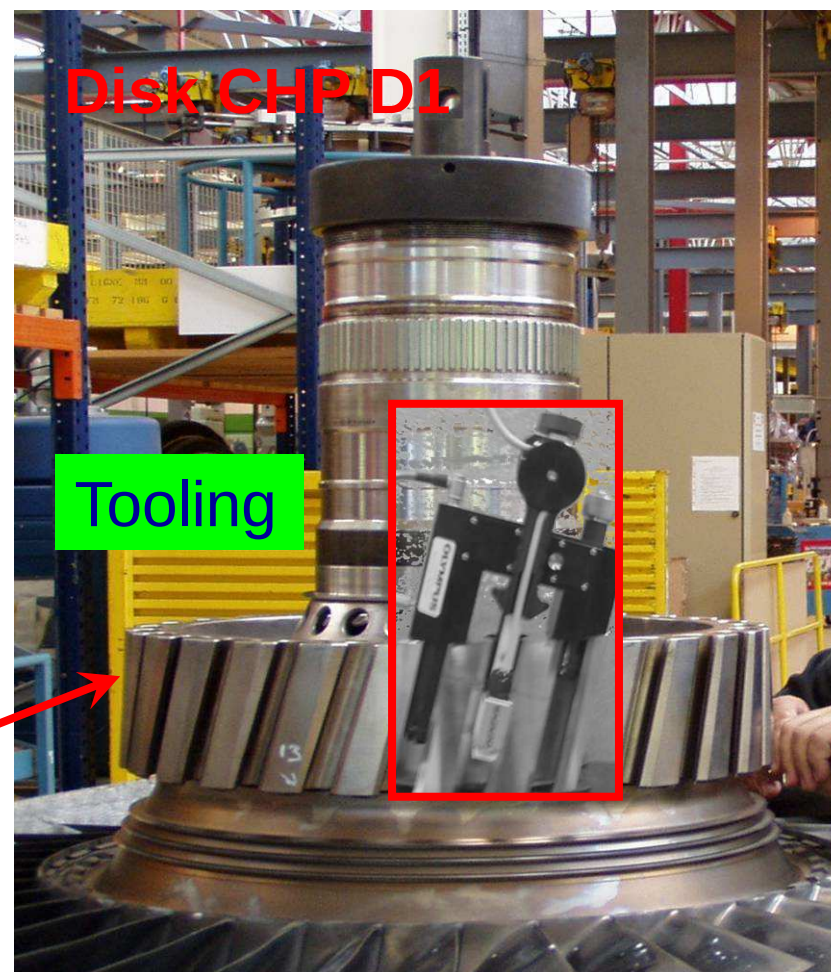
# ECA HF Inspection method

## Inspection in the maintenance shop

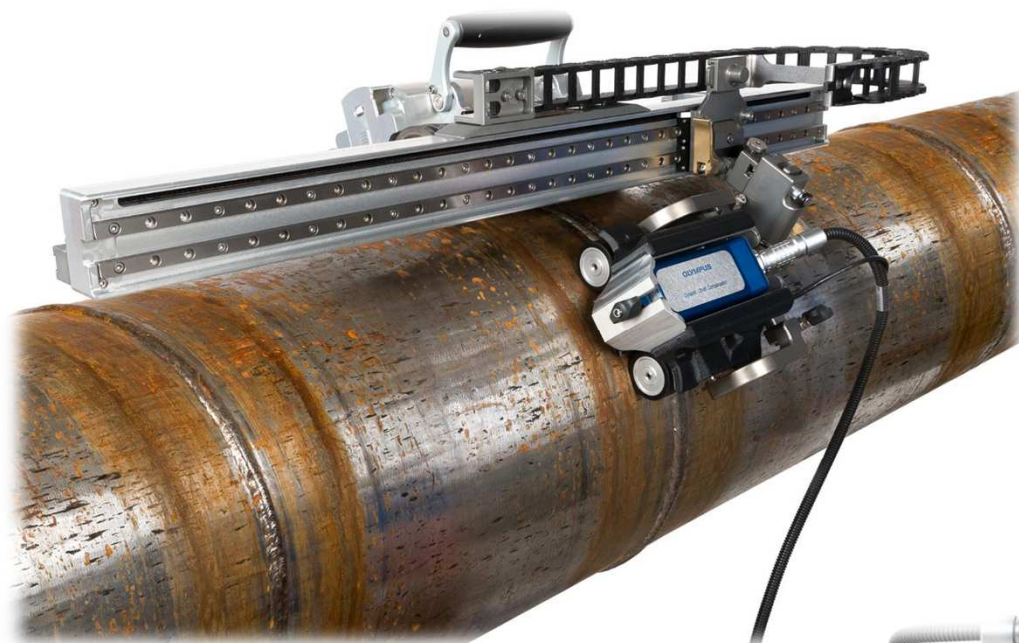
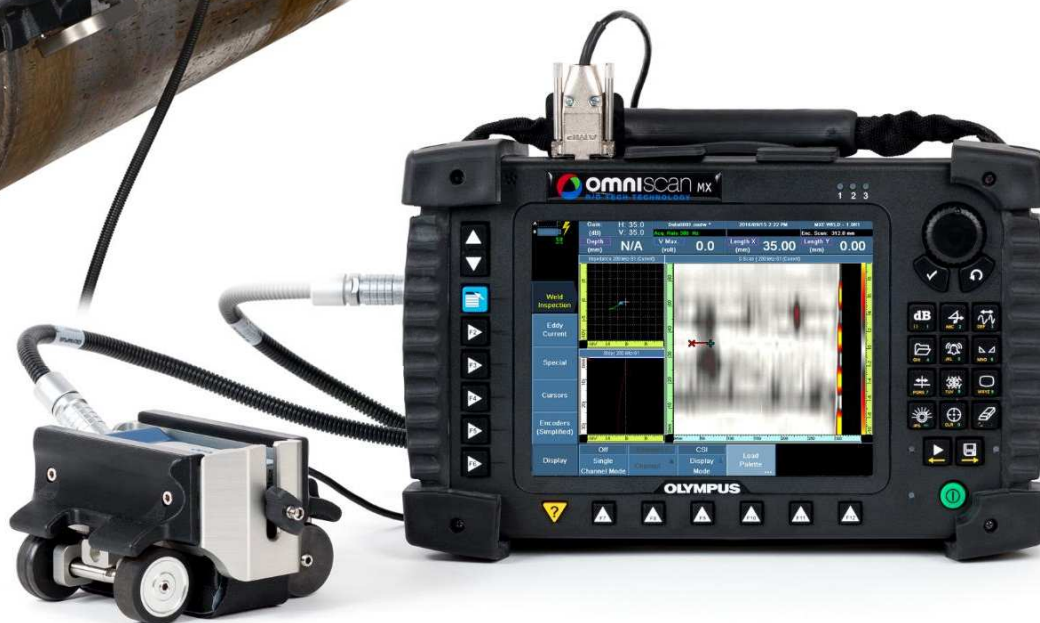
# Weld Inspection

- Pipe
- Windtower
- Rail

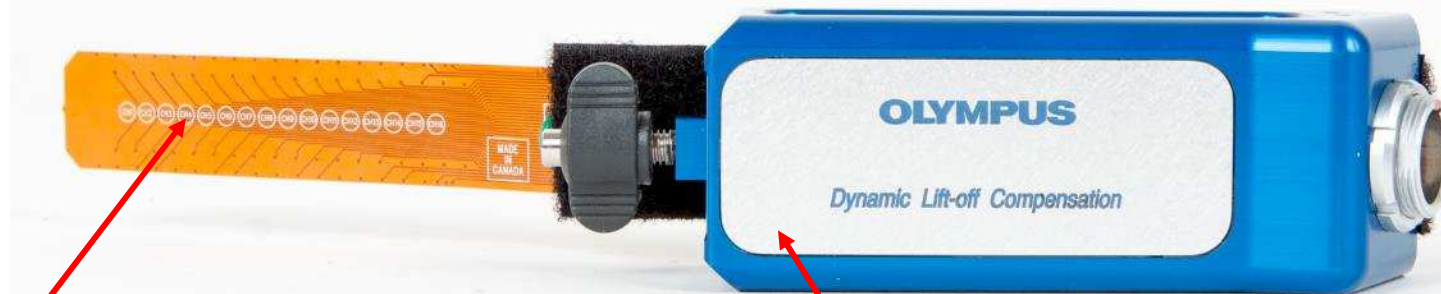
## Flexible Sensor Array

**16 + 16 Sensors  
(two types)**

**Active Circuitry**

**Eddy Current Sensors:  
Multi-Layer PCB Etched Coils**
